UNDERWATER BRIDGE INSPECTION REPORT

STRUCTURE NO. 6563

CSAH 7

ZUMBRO RIVER

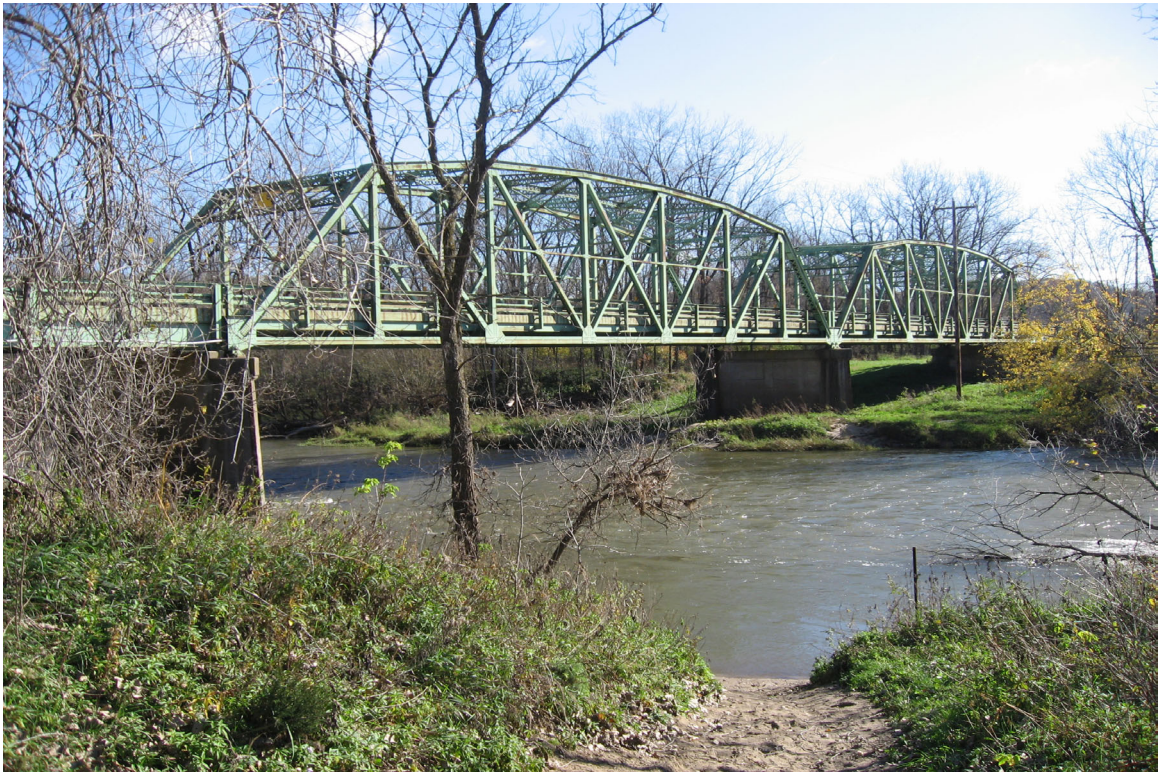
Photograph 1. Overall View of Bridge, Looking Southeast.

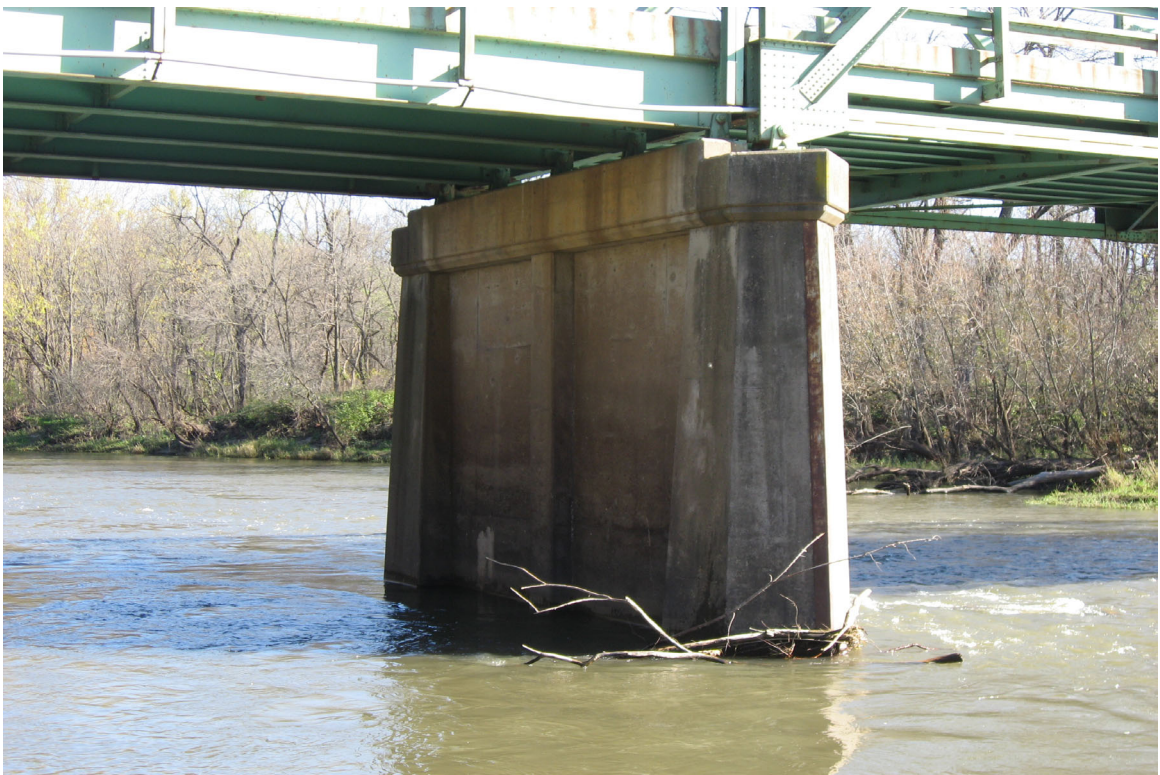
- (A) The top of the footing was located 5.2 feet below the waterline and was exposed around the entire perimeter of the pier. The full vertical height of the footing was exposed along the upstream nose, all of the eastern face, and along portions of the west face of the pier with undermining along those portions of the pier that was up to 1 foot high with up to 1.5 feet of horizontal penetration. The exposed timber piles along the undermined areas were all in good condition.

- (B) A heavy accumulation of timber debris consisting of 1-foot-diameter and smaller logs and branches was observed at the upstream nose of Pier 1 and also extended along the east face. The debris extended from the channel bottom up to 1 foot above the waterline.

- (C) Moderate scaling was observed along the pier shaft with penetrations ranging from 1/4 inch to 1/2 inch deep.
- (D) Heavy scaling was observed along the exposed footing with penetrations ranging from 1/2 inch to 1 inch deep.

Photograph 2. View of Pier 1, Looking Southeast.

- (A) The heavy accumulation of timber debris should be removed during routine maintenance.
- (B) The exposed footing and undermining observed at Pier 1 should be evaluated with respect to the scour potential and structural stability of the pier. Based on that analysis either scour counter measures may be necessary, or as a minimum, the conditions should be monitored during future inspections and after periods of high flow and/or high water levels.
- (C) Reinspect the submerged substructure units at the normal maximum recommended (NBIS) interval of five (5) years.

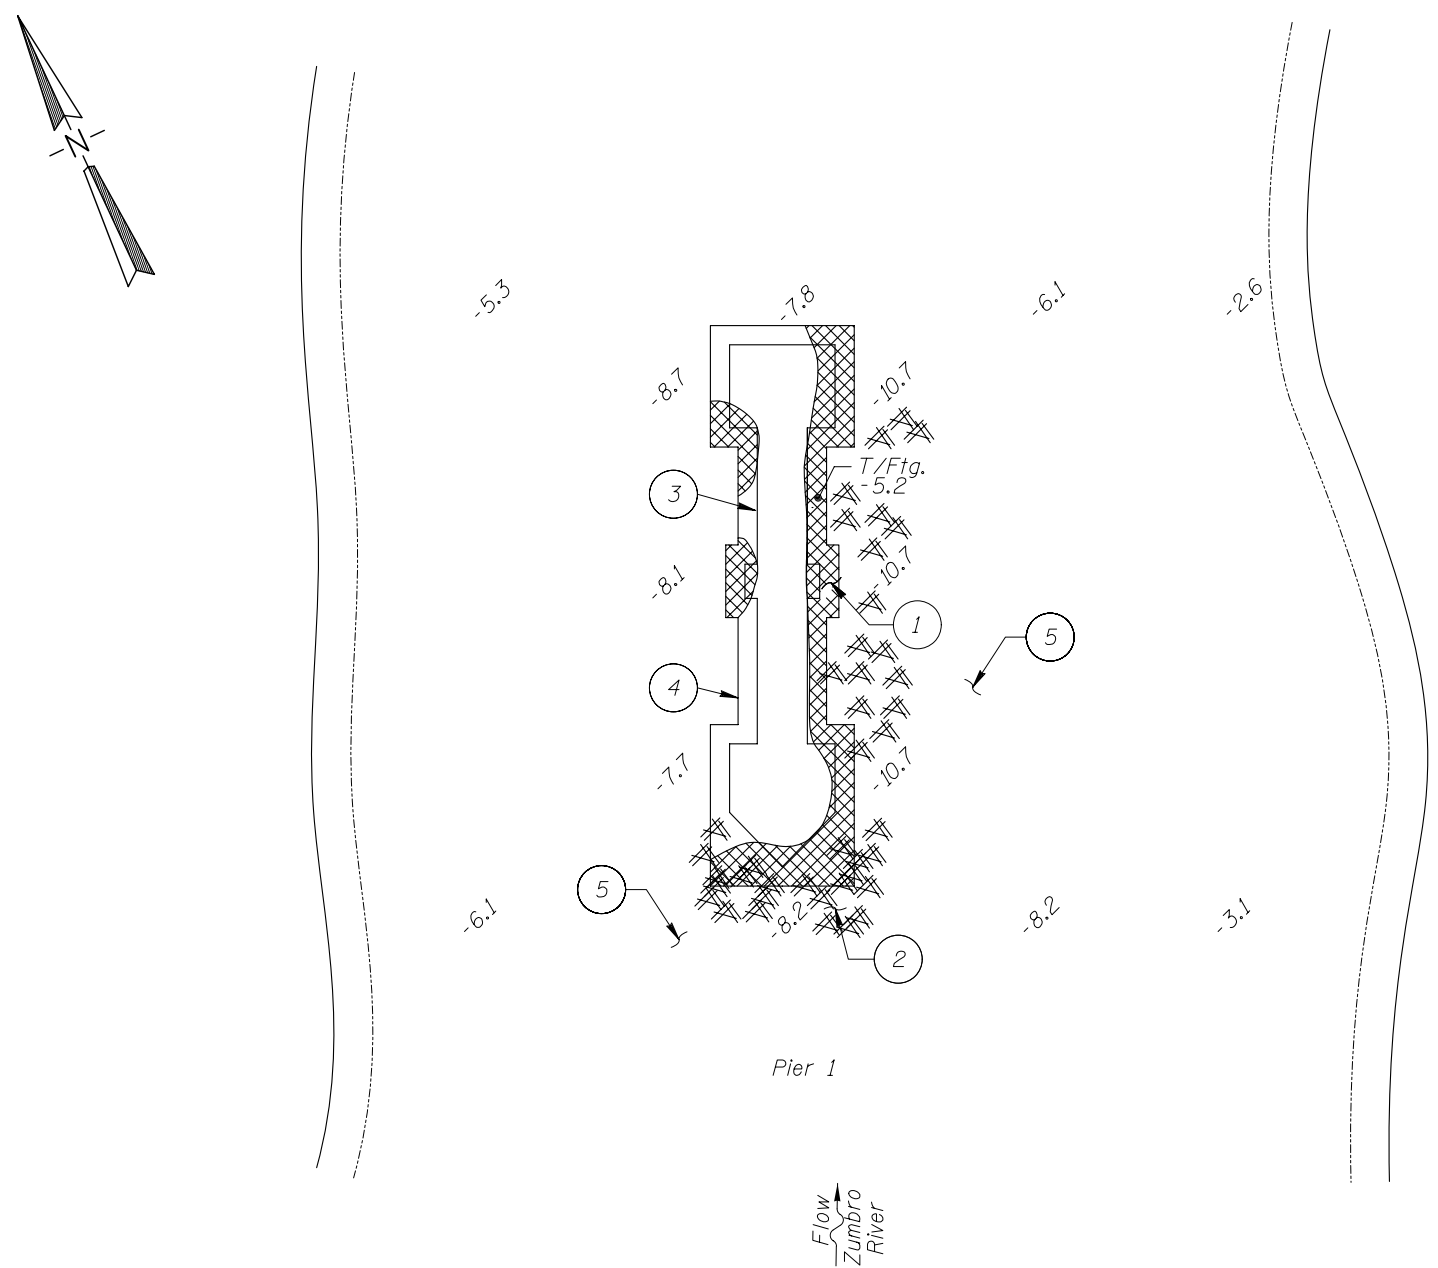
MINNESOTA DEPARTMENT OF TRANSPORTATION UNDERWATER BRIDGE INSPECTION		
STRUCTURE NO. 6563 OVER ZUMBRO RIVER DISTRICT 6, WABASHA COUNTY		
INSPECTION AND SOUNDING PLAN		
Drawn By: TWR	COLLINS ENGINEERS	Date: OCT. 2007
Checked By: DGS		Scale: NTS
Code: 52216563		Figure No.: 1

- 1 The top of the footing was located 5.2 feet below the waterline and was exposed around the entire perimeter of the pier. The full vertical height of the footing was exposed along the upstream nose, the entire eastern face, and portions of the western face of the pier with undermining along those sections of the pier that was up to 1 foot high with up to 1.5 feet of horizontal penetration. The exposed timber piles within the undermining were in good condition.

- 2 A heavy accumulation of timber debris consisting of 1-foot-diameter and smaller logs and branches was observed at the upstream nose and also extended along the east face of the pier from the channel bottom up to 1 foot above the waterline.

- 3 Moderate scaling was observed along the pier shaft with penetrations ranging from 1/4 inch to 1/2 inch deep.
- 4 Heavy scaling was observed along the footing with penetrations ranging from 1/2 inch to 1 inch deep.

- 5 The channel bottom consisted of firm rock with no probe rod penetration and large pieces of riprap (3 feet diameter and smaller) were observed at the upstream nose of the pier.
